**Region 9 Enforcement Division
75 Hawthorne Street
San Francisco, CA 94105**

Inspection Date(s):	9/29/2015		
Time:	Entry: 9:00 am	Exit: 10:00am	
Media:	Water		
Regulatory Program(s)	Clean Water Act NPDES /CAFO Dairy		
Company Name:	Bosch Dairy No. 2		
Facility or Site Name:			
Facility/Site Physical Location:	13567 South Whispering Lakes Lane Ontario, CA 91761		
Geographic Coordinates:			
Mailing address:			
Facility/Site Contact:	Bernard Bosch	Title: Operator	
	Phone: [REDACTED]	Email:	
Facility/Site Identifier:	NPDES CAG018001 / Order R8-2013-0001, General waste discharge requirements for CAFOs (dairies and related facilities)		
NAICS:	112120 Dairy Cattle and Milk Production		
SIC:	0241 Dairy Farms		
Facility/Site Personnel Participating in Inspection:			
Name	Affiliation	Title	Email
Bernard Bosch		Operator	
EPA Inspector(s):			
John Tinger	EPA	Engineer	Tinger.John@EPA.gov
Federal/State/Tribal/Local Representatives:			
Edward Kashak	WRCB-R8	Engineering Geologist	ekashak@waterboards.ca.gov

Appendix 1- INSPECTION CHECKLIST

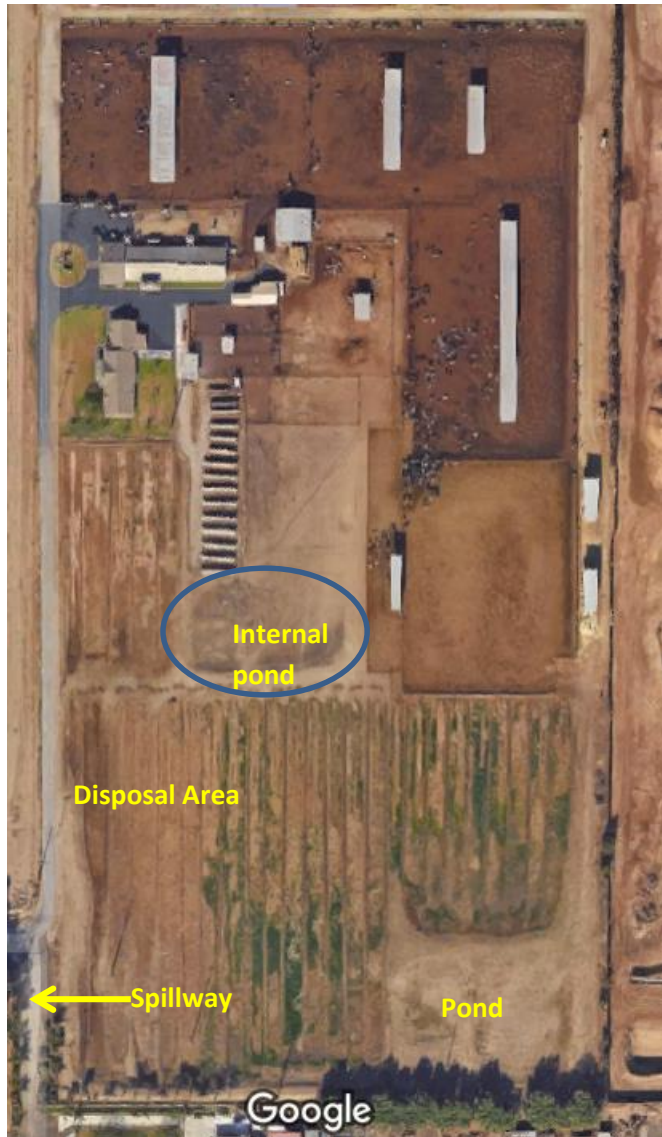
Stormwater generally flows in a southerly direction (see photo 1). Stormwater from the central/eastern portion of the facility first flows to the pond located in the center of the facility, and then may sheet flow to the disposal area and then to the pond in the south eastern portion of the facility.

Photo 1: Facility overview google earth.

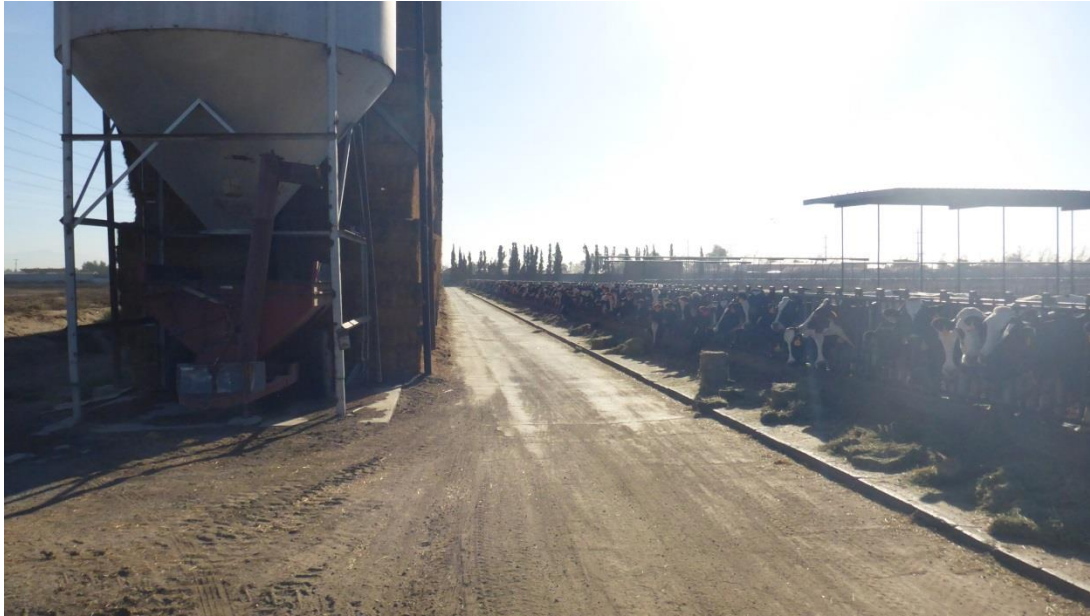
Photo 2: northern boundary of facility looking west.

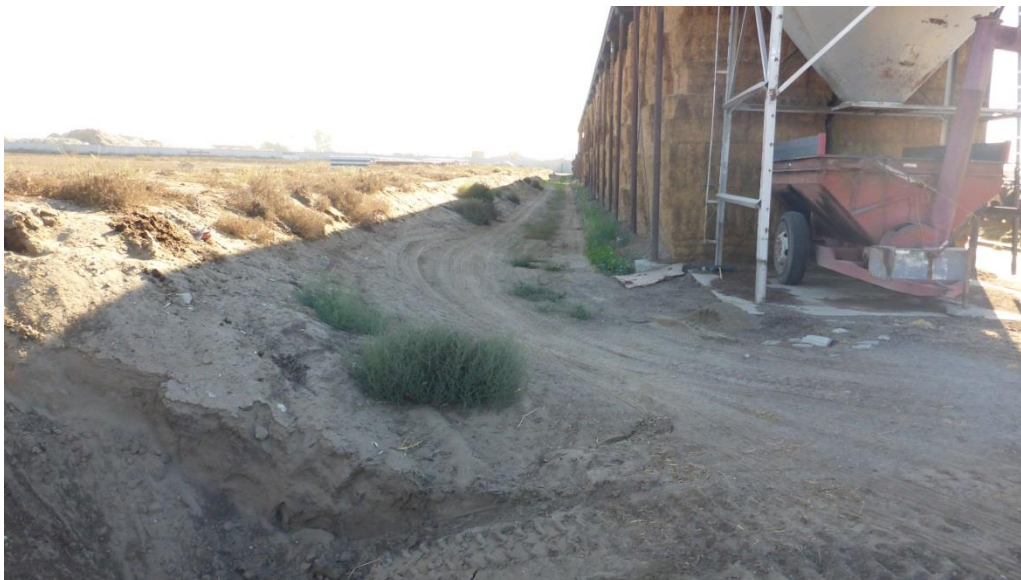
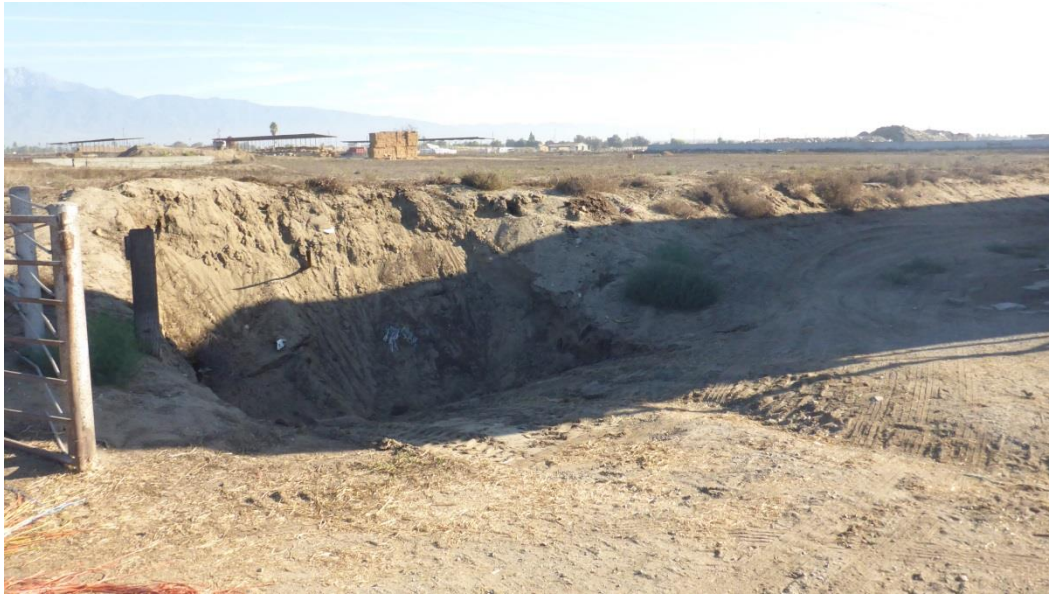
Photo 3: Pit dug in northwest section of facility to prevent discharge of feed materials onto roadway.

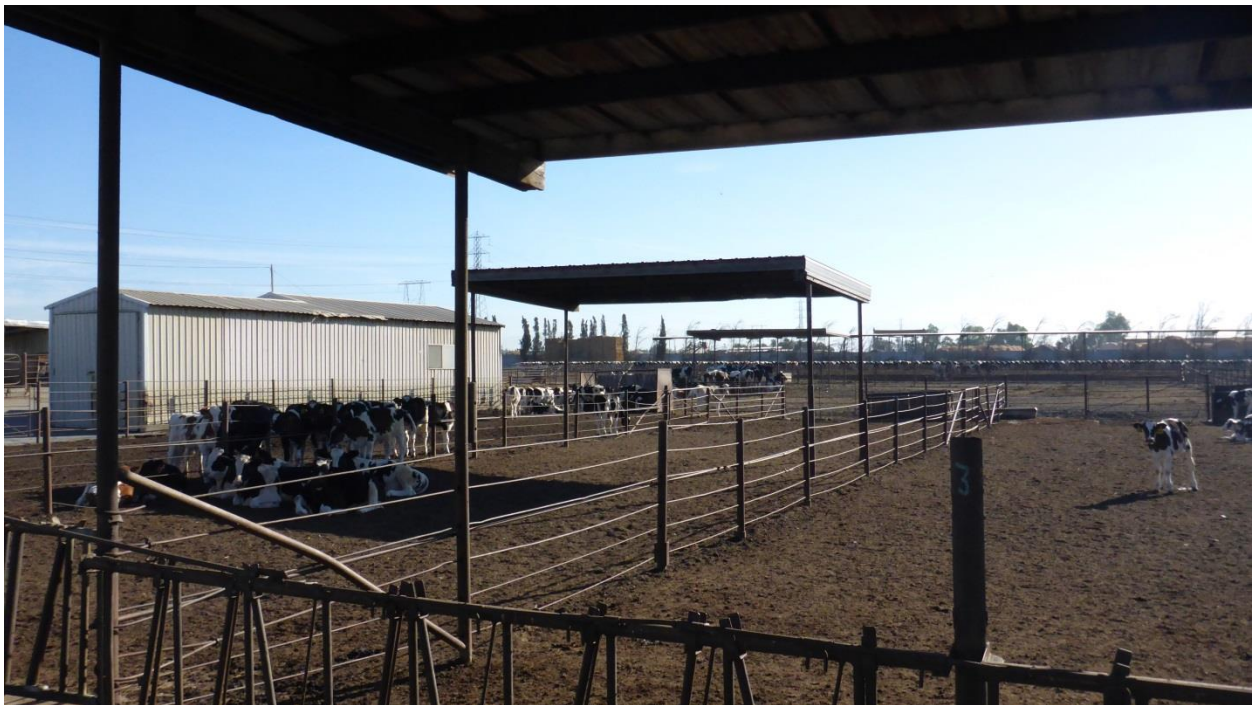
TYPICAL DEPTH OF MANURE IN CORRALS: < 6"

Photo 4: Corrals

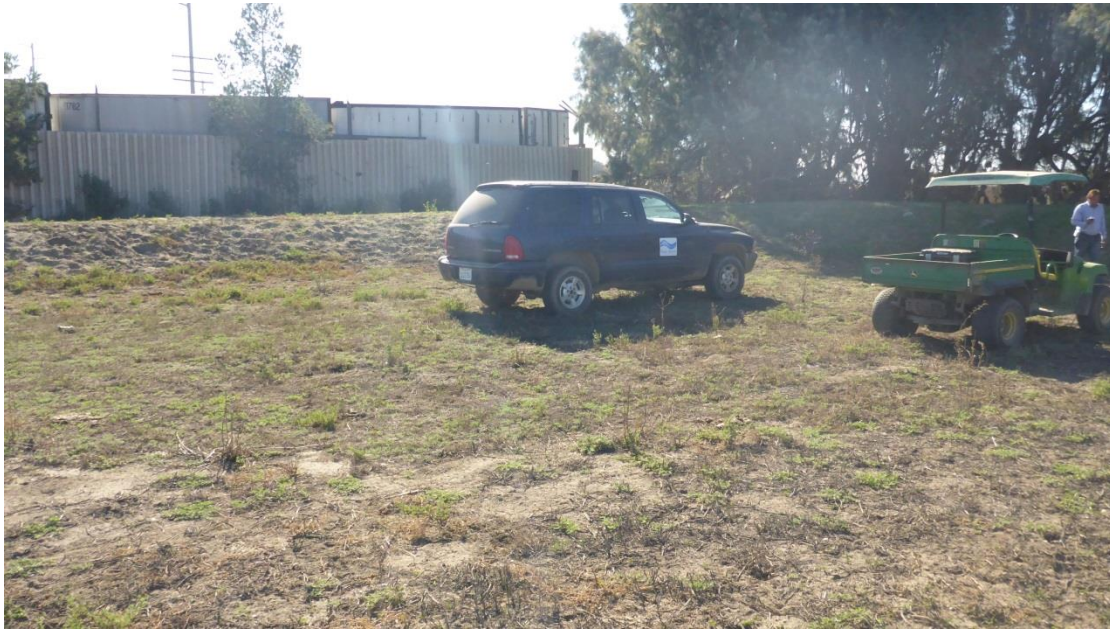
The southern ponds were dry. The operator did not know the last time solids were removed from the ponds. There was no evidence of accumulation of manure or solids in the southern ponds.

No evidence of significant rodent damage, erosion, or excess vegetation along berms was observed. Ponds generally clear of vegetation.

Photo 5: pond / berm at southeast corner of facility, looking southeast

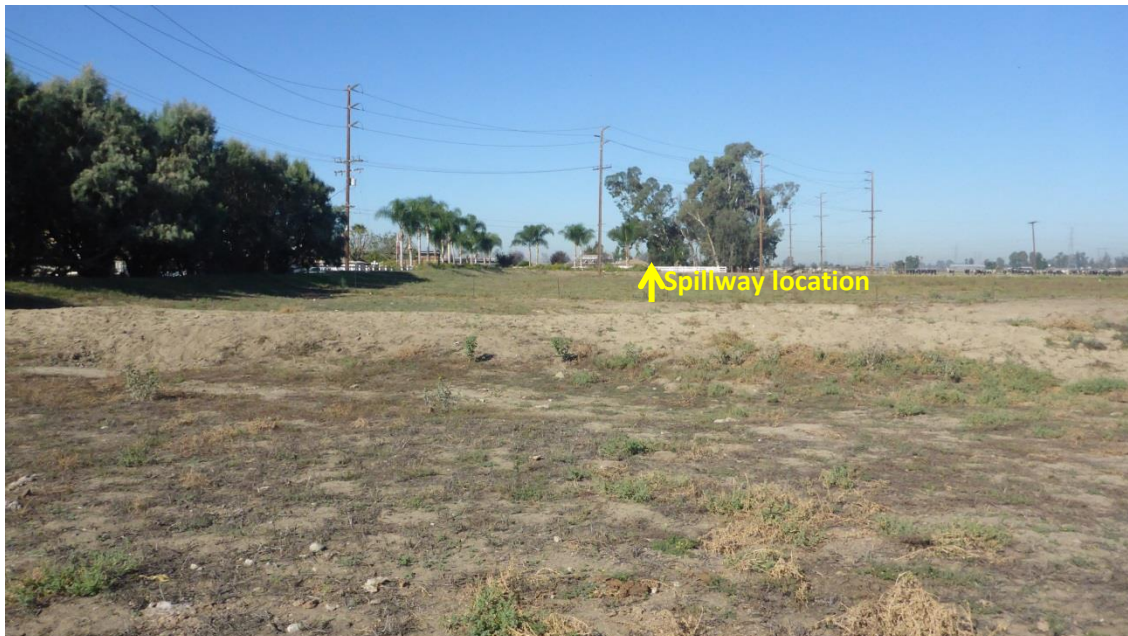
Photo 6: View of pond berm at southern edge of facility; looking west.

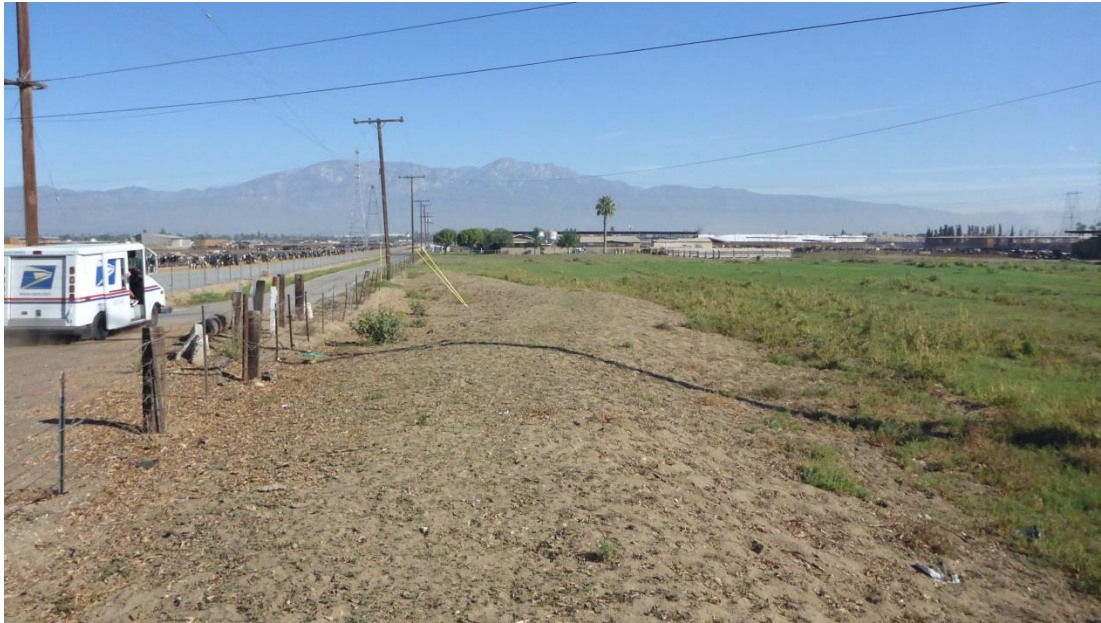
Photo 7: Berm along western edge of facility, looking north.

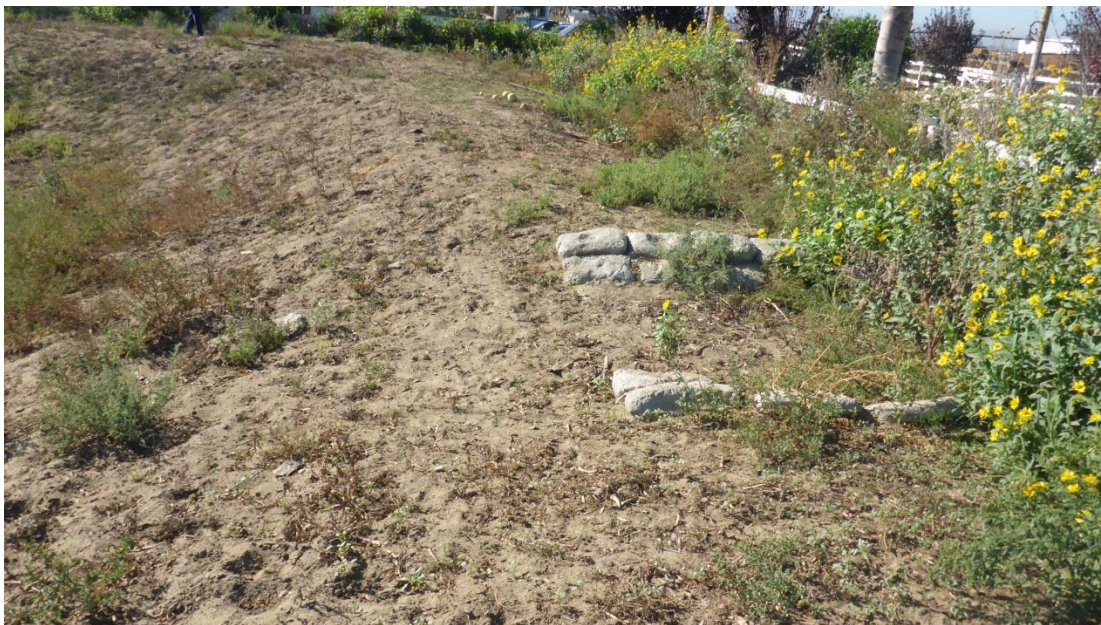
- The 2014 Manure Tracking Manifest and facility documentation did not appear to clearly document the destination of manure. Facility documentation of manure handling was not available on-site.
- The 2014 annual report did not contain nutrient analysis; the nutrient analysis was not available on-site.
- The concrete spillway had an accumulation of unconsolidated soil on top of the spillway which may block the spillway or cause erosion in event of overflow event.

The spillway appeared to have an accumulation of sediment which may have the potential to affect the integrity of the structure in the event of overtopping the constructed spillway.

Photo 8: Spillway; sediment accumulation on top of concrete.
